Norsonic Acoustic Camera

Filming sound leakages in highly reflective office environment

Measurements in office complex, Lier, Norway, April 2016

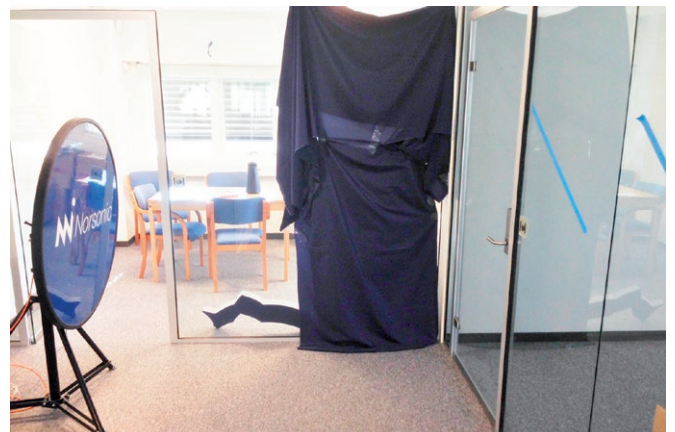
The first results from the initial recordings proved disappointing. Although it was possible to hear clear differences by using the virtual microphone, which enables the user to listen to specific points in the image, the coloring of sources was only seen on a glass facade standing perpendicular to the wall of interest, as seen on the left side in the image above. Clearly this was a strong acoustic reflection and not the main source itself.

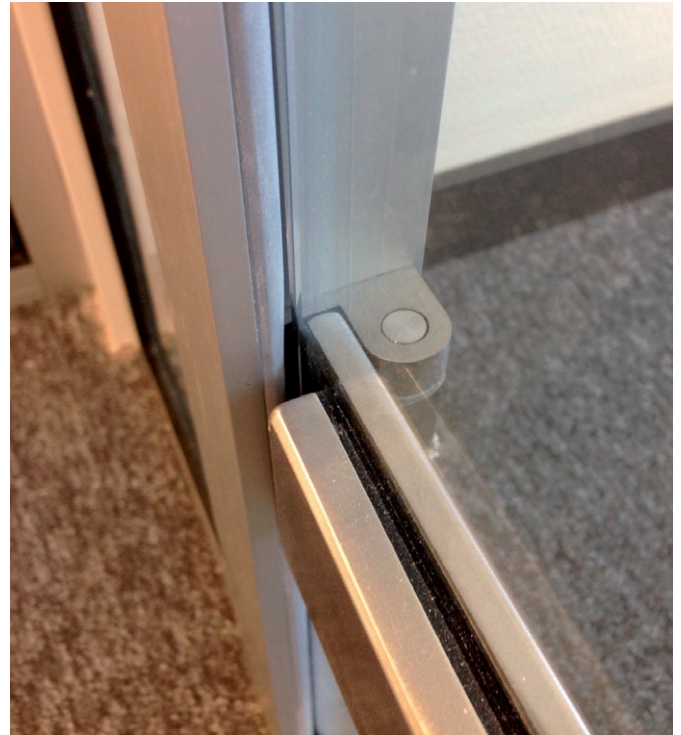
By studying the hinge in detail, one could easily see how the rubber seals weren't completely sealed off around the hinge, but left a small gap as seen in the image below. This gap allowed noise to leak through.

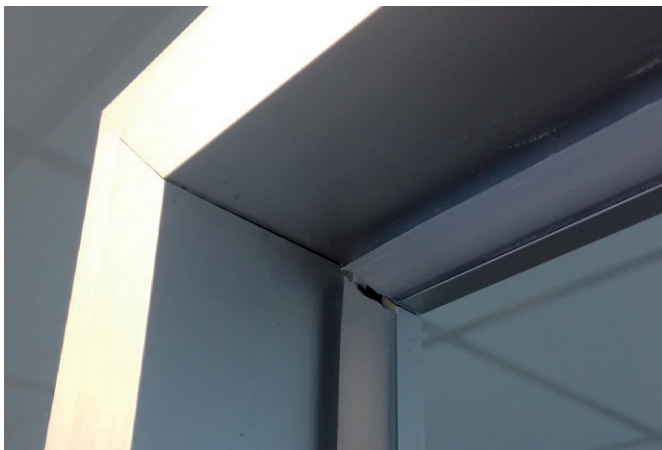
By closer inspection one could see how the rubber strip around the door edge wasn't completely sealed shut in this position as seen from the image below.

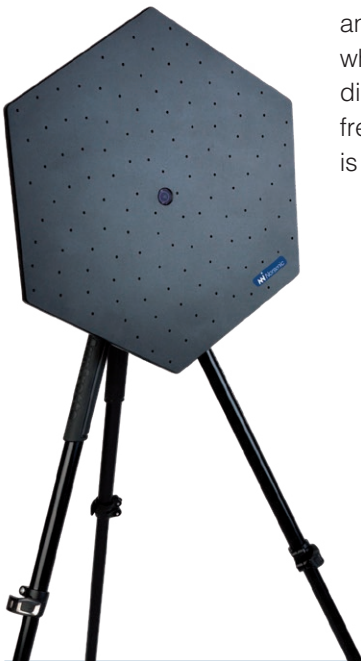
With a single Hextile, the user has a small, portable and lightweight acoustic camera that can be used for a wide range of measurement situations. The Hextile is a USB based acoustic camera, with a single USB cable for both power and data transfer – no extra battery cable needed. The array is made from robust and lightweight aluminium,

has 128 MEMS microphones, and is less than 3 kg in weight while having a maximum diameter of 46 cm. The low frequency limit for the Hextile is 410 Hz.

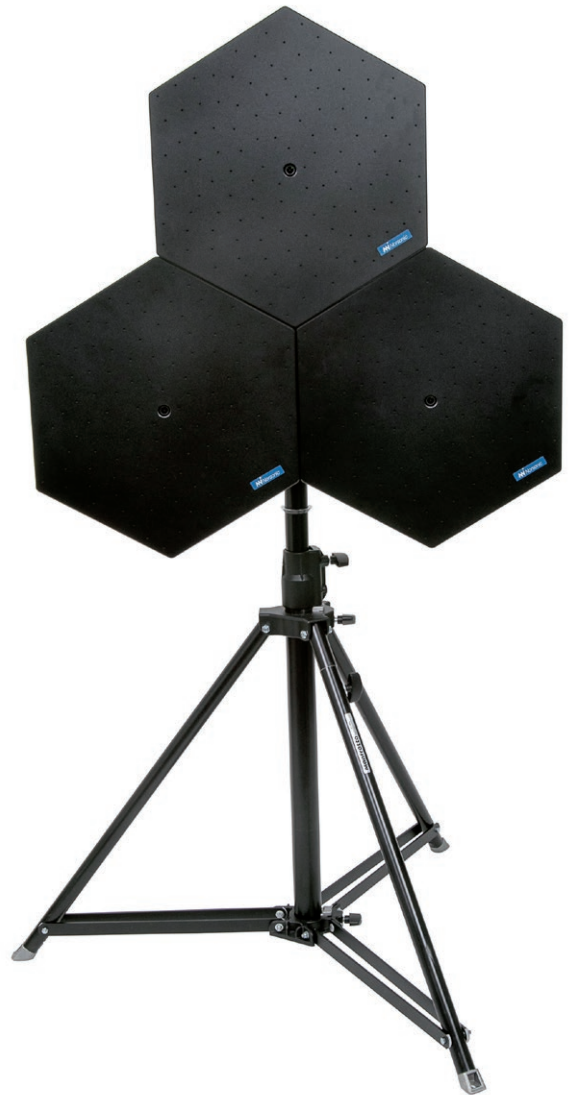
For users that require better resolution both in lower frequencies and overall, three single Hextiles can be combined to a larger Multitile system, consisting of 384 microphones with a maximum diameter of 96 cm. The low frequency limit for the Multitile is 220 Hz.

For special low frequency applications below 1 kHz, it is also possible to utilise the Multitile in the low frequency configuration as the Multitile (LF mode). By placing the individual Hextiles further away, the maximum diameter of the complete array system is increased to 1.46 m, making it ideal for low frequency measurements. The Multitile (LF mode) is for low frequency measurements below 1 kHz, with a lowest frequency limit of 120 Hz.
